Municipality of Jasper

Tactical Level Asset Management Study (Phase 2) – Water Distribution, Wastewater Collection, and Roadways

- Interim

2017-04-06

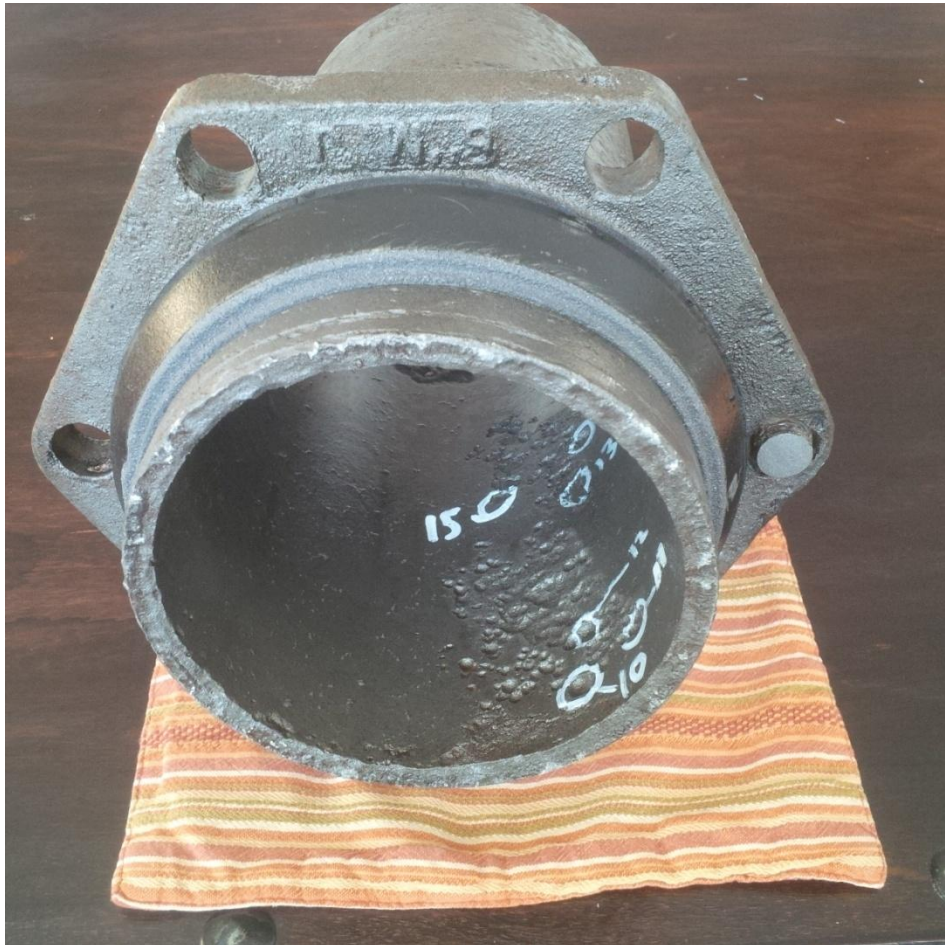
Figure 4 – Jasper Water Main #2871

During the condition assessment process, pipe #2871 was assessed using electromagnetic technology. The assessment computed the structural rating based on severity-extent measurements of the pitting (i.e. remaining wall thickness). During the field testing, a portion of the pipe was extracted for physical verification of the electronic data measurements. The following figure illustrates a photo of the pipe sample noting the pitting within the pipe.

Pipe segment #2871 is a 61 year old cast-iron 150 mm (6”) water main. It is located in Patricia Circle. Overall, the pipe is in reasonably good condition. It has approximately 5-6% of the surface area pitted. The majority is in the minor severity grouping (i.e. 50-80% remaining wall thickness). There is no major or sever pitting. Starting from the measured condition state in year 61, the following figure shows the Markovian performance prediction for this pipe segment. The pipe may likely reach the end of its service life in 30-35 years from today. However, it would be prudent to address remediation ahead of the high risk period (i.e. 20-25 years from today).

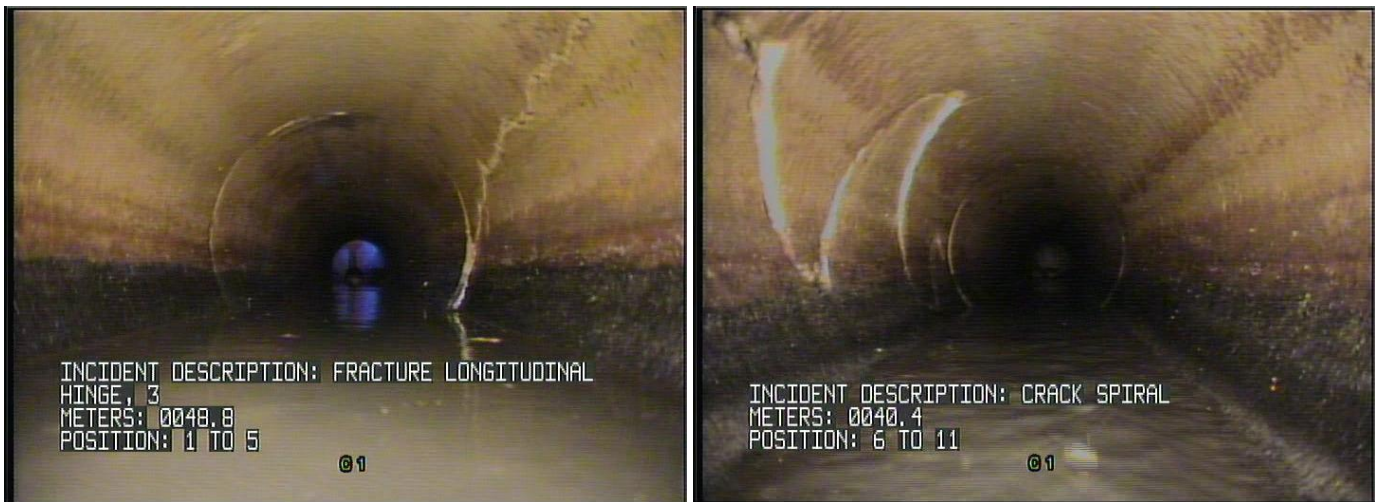
Figure 26 - Structural Condition Trigger for CIPP on Sanitary Pipe #JSD012

It should be noted that the structural condition triggering pipe lining through CIPP techniques is in the range of fair “3” to poor “4”. The structural condition triggering pipe replacement through bursting techniques is very poor “5”.

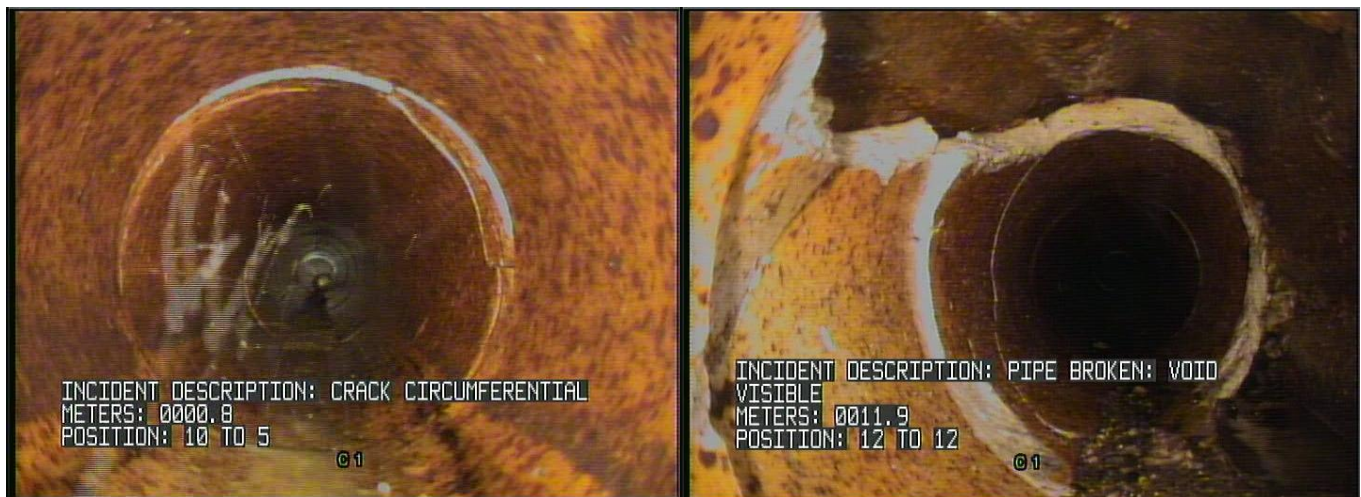
Figure 27 - Structural Condition Trigger for Pipe Bursting (Replacement) on Sanitary Pipe #JSD023

The following figure illustrates CCTV footage of pipe segment JSD023 indicating the structural conditions triggering replacing the pipe through pipe bursting. In this case the circumference cracking is accelerating (left) in places to which the pipe is beginning to fail (right) in places. As a result, the pipe needs to be replaced. Lining is only an option on excavation and repair of the broken sections, which has been calculated in the model to be less cost effective than pipe replacement.

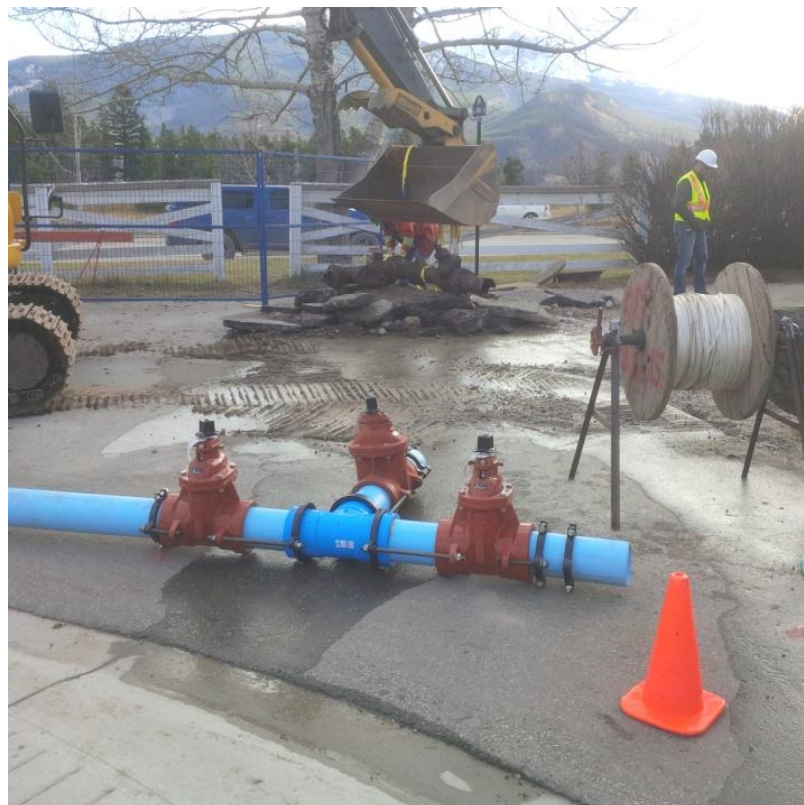
Figure 30– Patricia Circle Water Main Pipe #2871 Valve Assembly Replacement (Year 2016)

The following figure shows a valve repair that was occurring concurrent with the data collection within pipe segment #2871 in Patricia Circle.
