Jasper Activity Centre

Recreation Facility Assessment
April 2016

Architecture
Interior Design

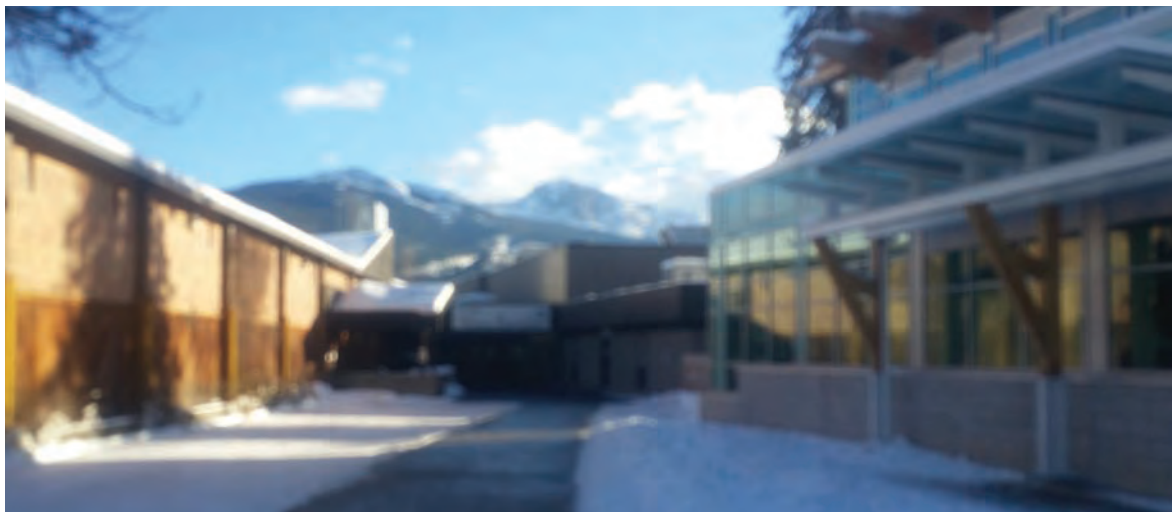
The main entry to the facility is on the west side of the building and is set back from the street by over 60m. It is pinched between two wings of the building with an overhang at the entrance that is low and finished with a dark wood material providing very little light into the area in front of the entrance. The ground surface is a recycled rubber tile finish and is difficult to maintain in winter conditions. Several of the tiles were missing at the time of our evaluation. The doors are solid and also contribute to the dark and unwelcoming entrance to the building.

The distance of the main door to the street, combined with the narrow access route, does not conform with current fire fighting access design (ABC 3.2.5.5)

Image 2, Approach to the main entry. The exterior exit door from refrigeration room is at the entry on the left

Recommendation: A careful redesign of the entrance, approach and overhang area should be undertaken to improve the appearance of the entry and address the operational concerns related to snow clearing on the rubber tiles. Sidewalks and turf stone should be removed and replaced

with proper surfaces and drainage issues require attention to keep the water from ponding and freezing at the front entrance. Changes must be made to provide a conforming fire fighting access route.

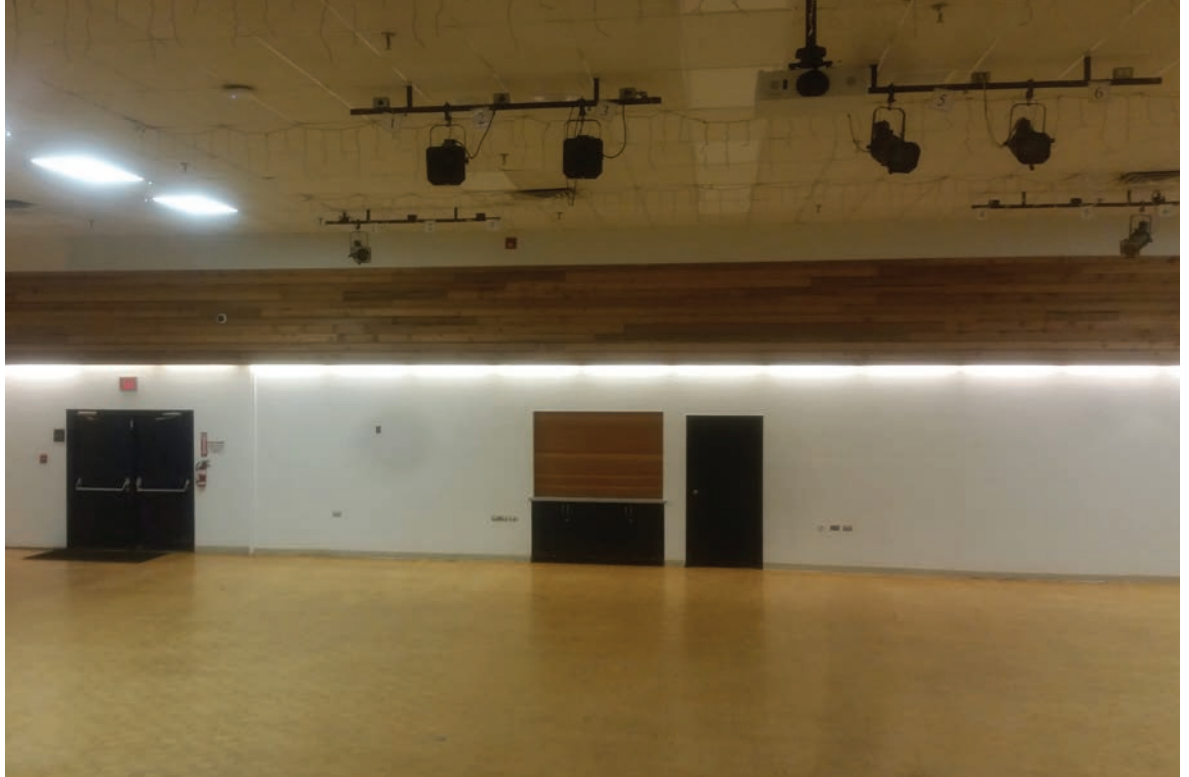
The finishes in the multipurpose room are showing a great deal of wear. The flooring has exceeded it's life span and matching flooring stock is not available for future repairs. The operable wall that divides this space from the arena lobby is very worn and becoming difficult to operate.

Image 3, Multipurpose room finishes. Ceiling tiles are worn, wall finishes are dated and floor is past it's serviceable life span

Recommendation: New flooring, ceiling, and wall finishes should be considered and the operable wall should be replaced. Reconfiguration and possibly expansion of the multipurpose

room should be considered to provide views to the mountains and better serve large gatherings. The kitchen should be renovated to meet current mechanical building code requirements. Investigating appropriate dance flooring so ensure the flexibility of the space should be part of the scope for this room.

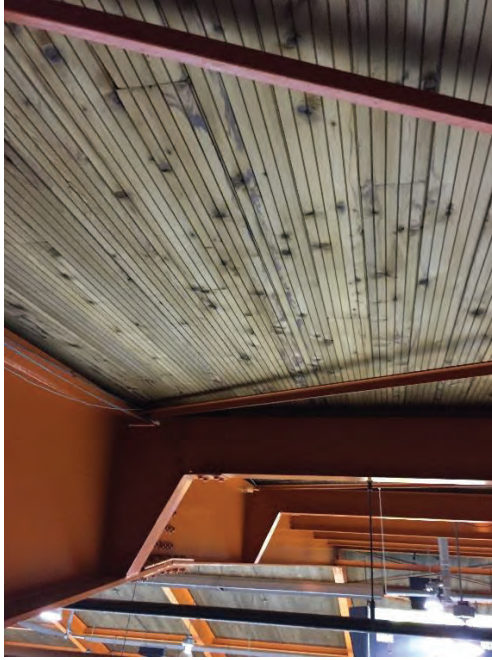
Figure 5.1: Arena – Steel Roof Structure (Water Staining of Timber Decking)

- .1 As shown in Figure 5.1, the timber roof appears to be in good condition; however, water staining was observed between the plank laminations.
- .2 As shown in Figure 5.2, visible cracking of the concrete SOG was observed. Since destructive testing was not performed, the depth of the crack was not determined. The crack was linear in direction and located on the North East end of the arena.

As shown in Figure 5.1, the timber roof appears to be in good condition; however, water staining was observed between the plank laminations. It is our recommendation the source of water staining between the timber planks be determined. The wood in the stained areas should be checked for rot.

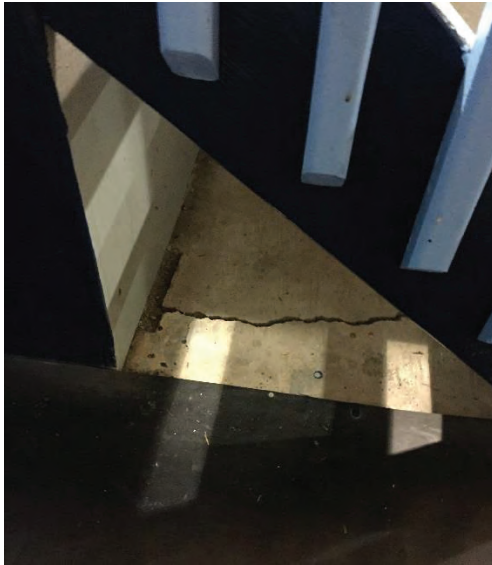
Figure 5.2: Arena – Main Floor (Slab-on-Grade Crack)

As shown in Figure 5.2, visible concrete cracking of the SOG was observed. Since destructive testing was not performed, the depth of the crack was not determined. The crack was located on the North East end of the arena and was linear in direction. It is our opinion that the cracks around the ice rink are not of structural concern nor do they pose any major safety risk. The estimated cost to locally repair the SOG is in the order of \$7,500.

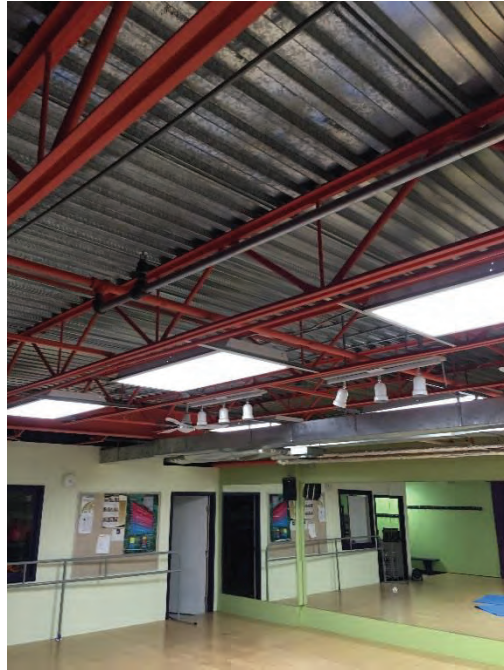
Figure 5.3: Multi-Purpose Hall – Main Floor Steel Structure (Missing Fire Spray)

- .1 As shown in Figure 5.3, no fire spray was observed on the main floors metal deck nor open web steel joists and steel structure.

As shown in Figure 5.3, no fire spray was observed on neither the main floors metal deck nor open web steel joists and steel structure. The Architect should confirm if a fire rating assembly is required, and if so, this portion of the structure would not meet the Alberta Building Code and application of fire resistance spray would be required.

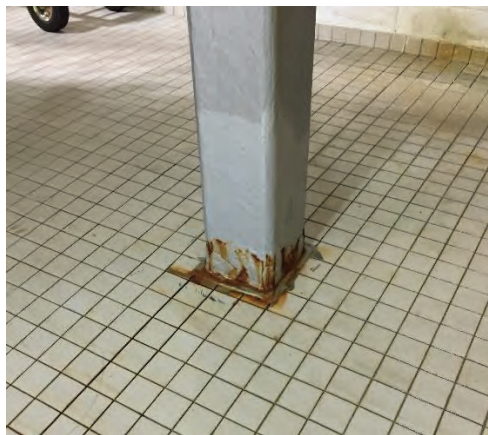
Figure 5.4: Natatorium – Main Floor Column (Corrosion at Base of Columns)

- .1 As shown in Figure 5.4, significant corrosion was observed at the base of the majority of steel columns. It appears the columns have been re-coated with paint to mitigate the risk of future corrosion. However, the coating does not appear to be effective as the significant corrosive staining was observed. Since nondestructive testing was not performed the severity of the corrosion was not determined.
- .2 As shown in Figure 5.5, significant corrosion of the water slide steel stair was observed.

As shown in Figure 5.4, significant corrosion at the base of the majority of steel columns was observed. It appears the columns have been re-coated with paint to mitigate the risk of future corrosion. Since non-destructive testing was not performed, the severity of the corrosion was not determined. Due to the appeared severity of the corrosion, we strongly recommend destructive site testing be taken from each steel column within the Natatorium to better determine the remaining steel thickness. Completion of this test will determine the severity of the corrosion and allow us to determine the load carrying capacity of the structure. Until the non-destructive testing is performed, we are unable to estimate the cost of restoring/repairing the corroded columns. We estimate the cost of the non-destructive testing, along with an analysis of each columns load carrying capacity, to be in the order of \$12,000 to \$17,000, excluding expenses.

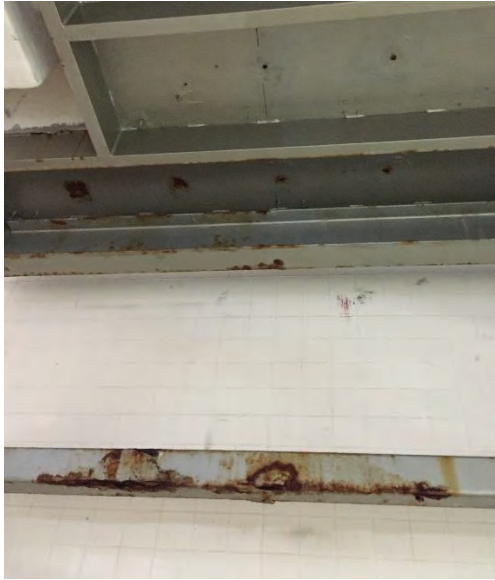
Figure 5.5: Natatorium – Steel Stair (Corrosion of Typical Stair Members)

The steel stairs up to the slide start are showing significant signs of wear and corrosion (refer to structural report in section 6 for more detail). The slide itself has deteriorated to the point that the fiberglass surface represents a serious injury risk as glass fibers have become loose. The manufacturer of the slide is unavailable to provide replacement sections of the slide and other repair methods have not provided a durable solution.

As shown in Figure 5.5, significant corrosion of the water slide steel stair was observed. It is our recommendation that the corroded steel stair be removed and replaced with a structure less susceptible to corrosion. Due to the severity of the corrosion, and because destructive testing was not performed on corroded members, we are unable to determine the life expediency of the stair.

Recommendation: A replacement slide is required to be designed and installed. New stairs and rehabilitation of the stair structure is also required.

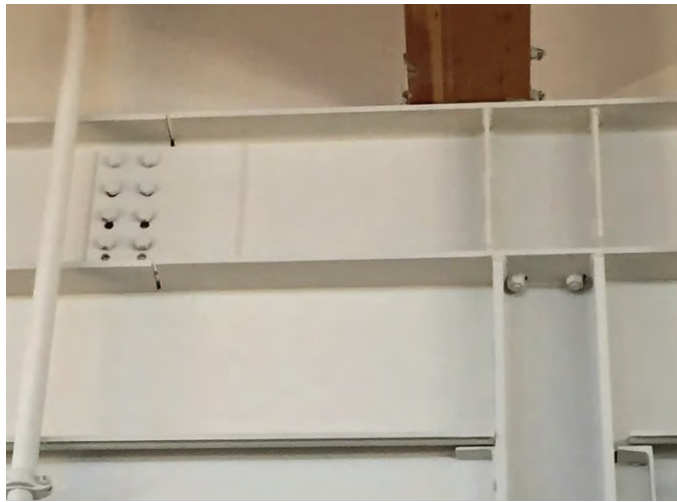
Figure 5.6: Fitness – Steel Columns (Bolt Spacing)

As shown in Figure 5.6, roof beam to roof girder bolted connection contains a bolt spacing that appears to be less than the minimum allowable by code. It is our recommendation the Engineer of Record should comment on the load carrying capacity of the bolted connection.

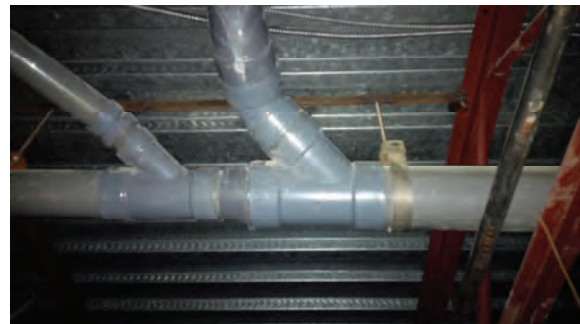
Plastic pipe in basement R/A plenum
