Municipality of Jasper

Tactical Level Asset Management Study (Phase 2) – Water Distribution, Wastewater Collection, and Roadways

- Interim

2017-04-06

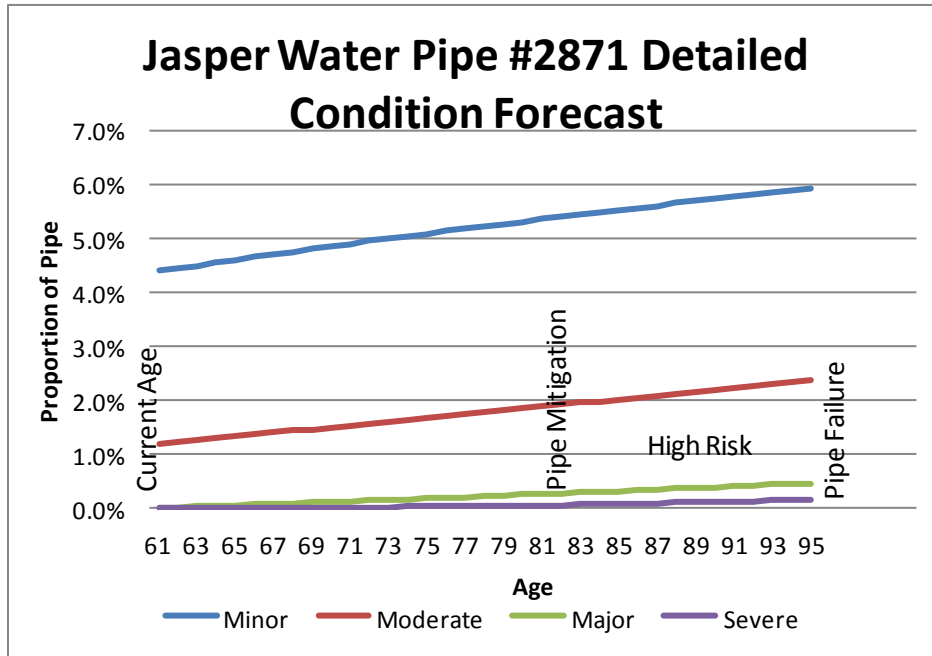
Figure 5 – Severity Level Performance Prediction - Water Main #2871

Pipe segment #2871 is a 61 year old cast-iron 150 mm (6”) water main. It is located in Patricia Circle. Overall, the pipe is in reasonably good condition. It has approximately 5-6% of the surface area pitted. The majority is in the minor severity grouping (i.e. 50-80% remaining wall thickness). There is no major or sever pitting. Starting from the measured condition state in year 61, the following figure shows the Markovian performance prediction for this pipe segment. The pipe may likely reach the end of its service life in 30-35 years from today. However, it would be prudent to address remediation ahead of the high risk period (i.e. 20-25 years from today).

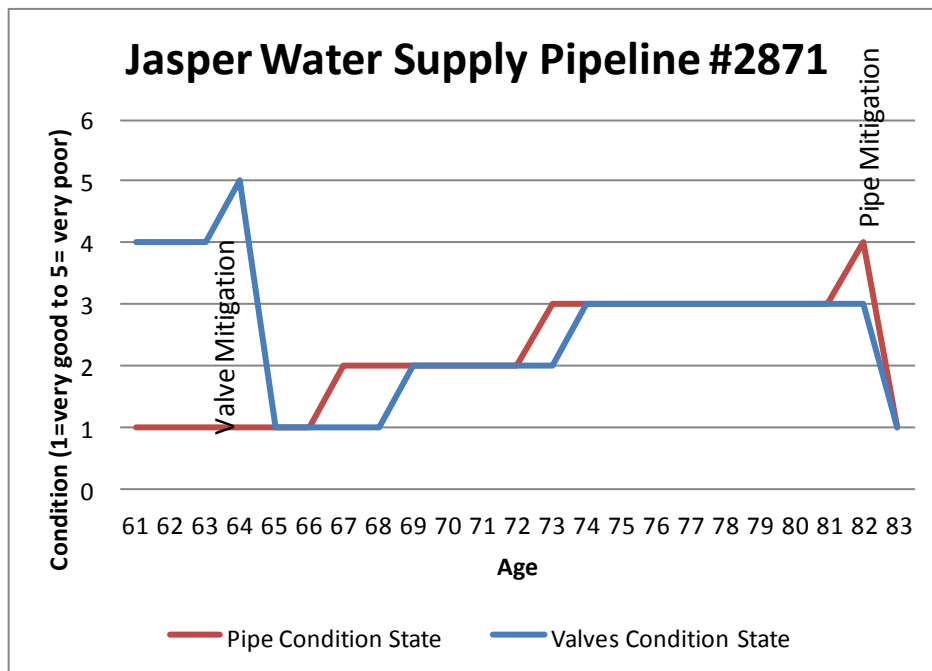
Figure 6 – Condition State Performance Prediction - Water Main #2871

The following figure illustrates the condition state modelled over time with the treatment options applied. In this example, the graph shows two condition parameters; one for the pipe and the other for the valves. Today, the pipe is still in a very good (state 1) condition state. The associated valves along the line are projecting near the end of its service life and showing they will be replaced soon, or have been recently replaced. The pipe is showing reaching a poor (state 4) condition state in approximately 20 years from now. The modeling treatment strategy forecasted a “Pipe Bursting” treatment at this time, which reset the condition state of the pipe and associated valves to a very good (state 1) condition state.

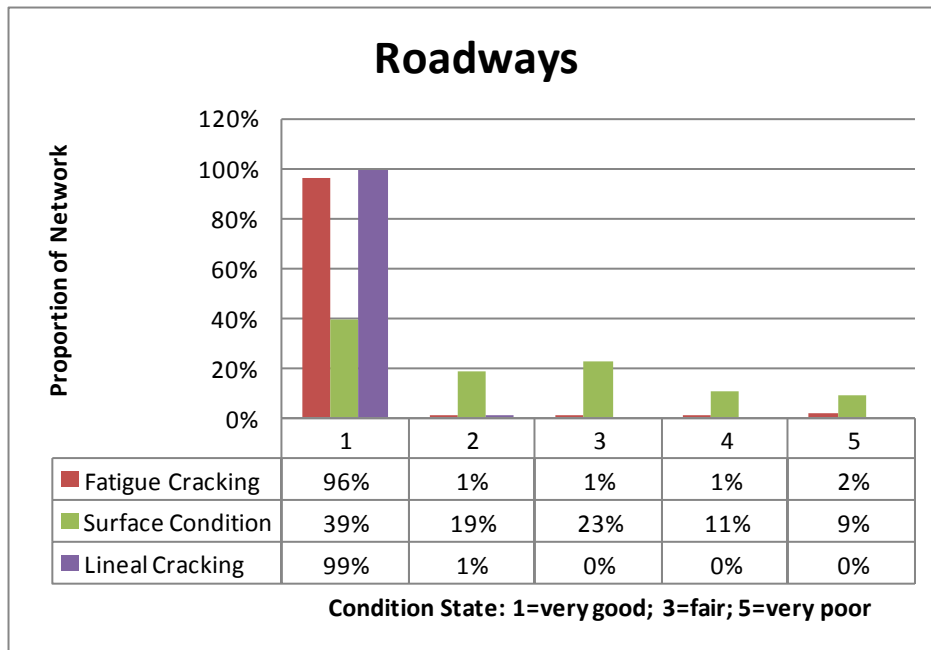
Figure 8 – Roadways State of the Infrastructure

Overall, the roadways are in fairly good condition. They are structurally sound with no indication of subsurface failure. The primary concern is poor to very poor surface condition on approximately 20 percent of the roadways. The surface is beginning to ravel. This is a loss of binder around the aggregate and the roadways are taking on an exposed aggregate appearance. In some cases, this has progressed to a loss of aggregate and eventual potholes. Timely remediation could seal the surfaces to a near new condition state. However, if deterioration progresses, then full pavement rehabilitation will be required at five times the cost of preventative maintenance such as a micro-surface. Roadways are in a timely sensitive stage in its lifecycle. Deferral of works could significantly increase the cost to renew this infrastructure group.

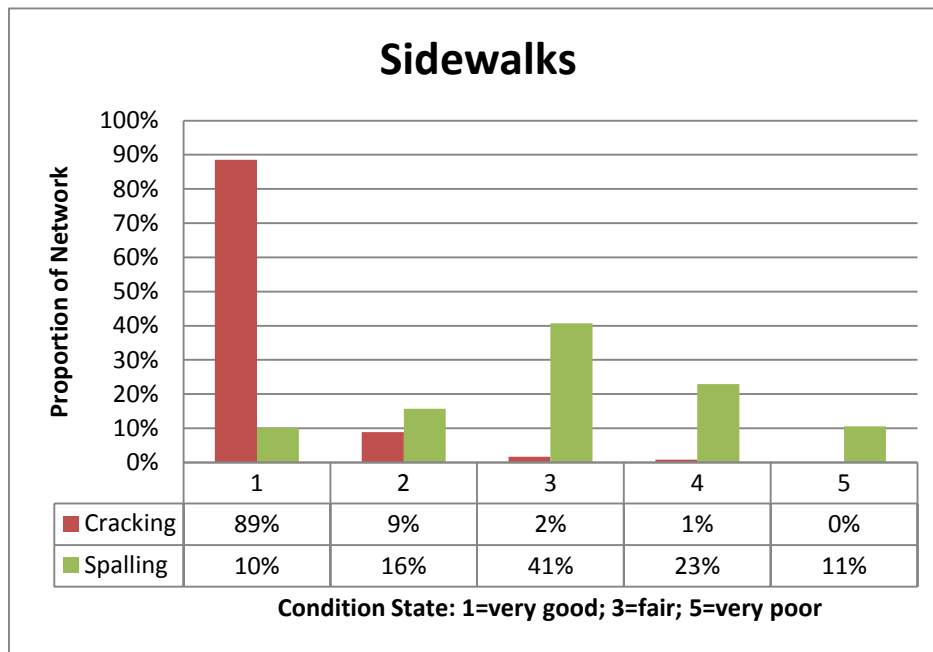
Figure 9 – Sidewalks State of the Infrastructure

Overall, the sidewalks are in fairly good condition. They are structurally sound with no indication of subsurface failure. This is shown by very little cracking and heaving. The primary concern is the poor to very poor spalling on approximately 34 percent of the sidewalks. This is often a result of the aggregate quality and/or salts used for roadway de-icing. On inspection, it was observed that some of the newer sidewalks were spalling quicker than the older sidewalks. This is an indication that quality control may have changed over recent years.

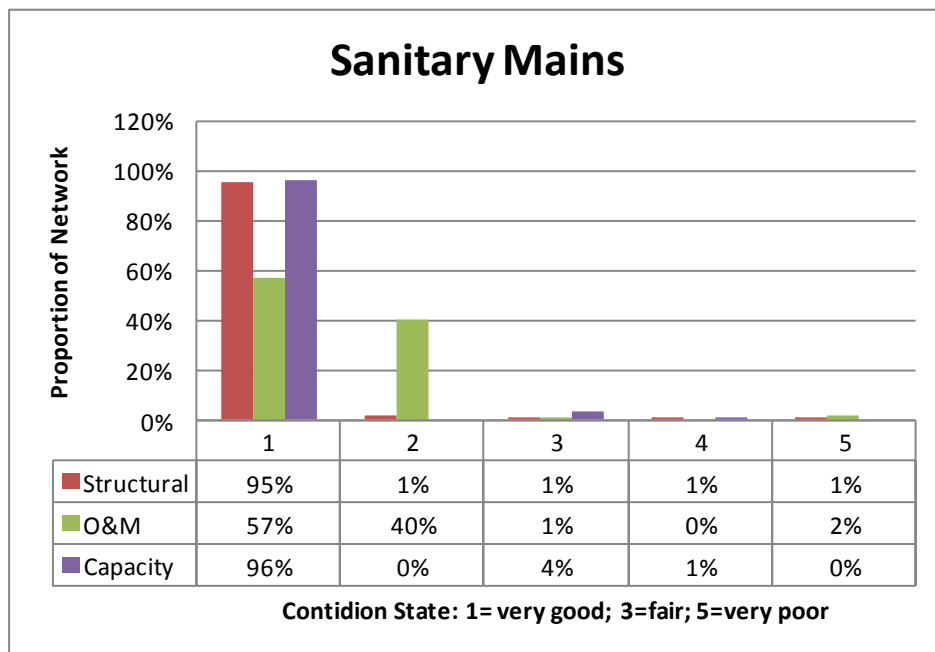
Figure 10 – Sanitary Mains State of the Infrastructure

The following figures present the Sanitary Mains and Storm Mains state of the infrastructure. The sanitary mains network appears to be in a good condition state. Approximately 2 percent of the network may have a structural concern requiring some form of attention. The more significant issues are operations and maintenance (i.e. O&M) relating to build up of scale along the pipe wall and roots infiltrating through pipe joints. Alternatively, the storm mains network appears to be in very good condition from both the structural and O&M perspective. This is likely related to the nature of the sanitary effluent, due to its corrosiveness and nutrient content.

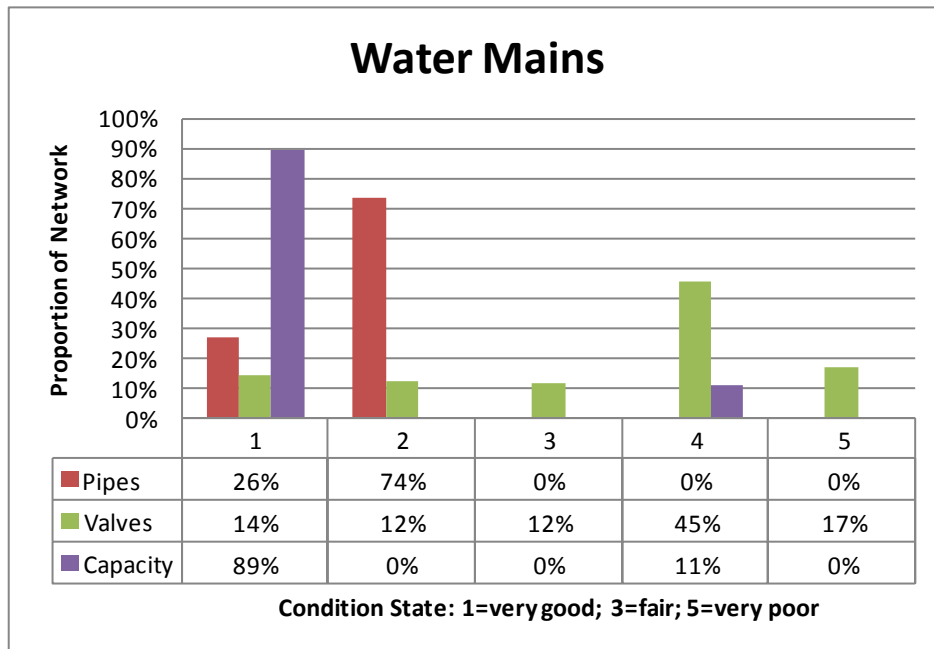
Figure 14 – Water Mains State of the Infrastructure

The following figure presents the Water Mains state of the infrastructure. Water mains were the most challenging infrastructure group in acquiring condition data. The municipality had very little information on the pipe break history. Most occurrences were noted around valve failures, not necessarily the pipe. Very good pipe condition data was however attained for one 61 year old cast iron pipe segment (#2871) in Patricia Circle. This was the correlation sample for the rest of the network. At this time it was noted some recent valve/hydrant replacements on Patricia Circle. A valve assembly was also being replaced on pipe segment #2871 concurrent with the data gathering. This provided some indication that the service life of the water main valves was shorter than the pipe segments. This was a factor in the tactical level analysis moving forward.

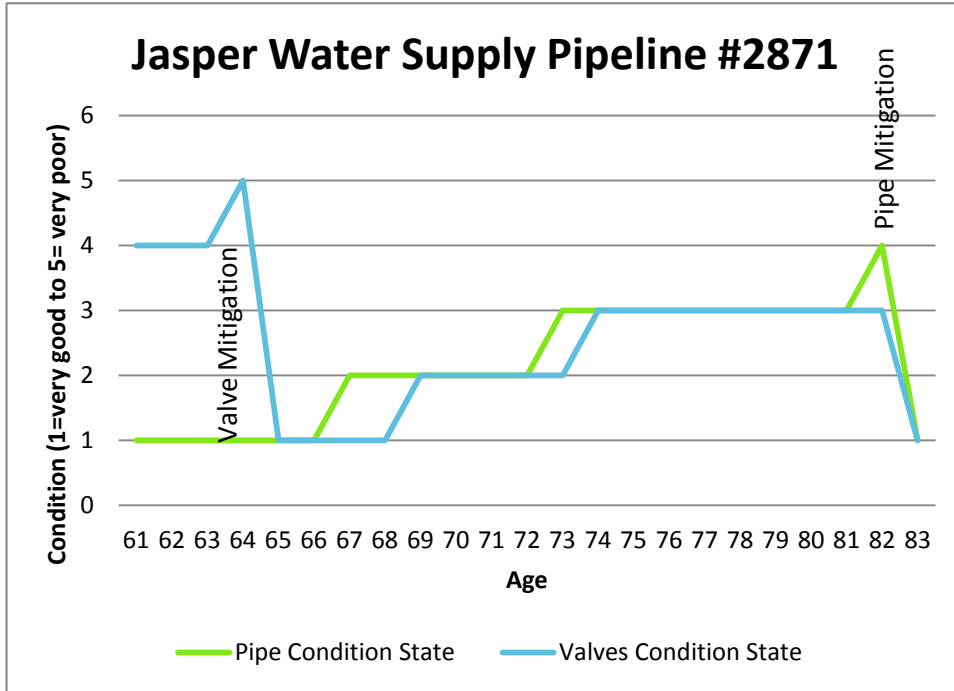
Figure 29– Condition State Performance Prediction - Water Main #2871

The following figure shows the expectation of renewal needs between pipe and valve. In the prediction model, we include a probabilistic allowance for valve failure and associated valve repair within the pipe lifecycle. Then when the pipe is eventually replaced, renewal occurs for all components associated with the pipe (i.e. pipe, isolation valves, hydrants, and service connection).

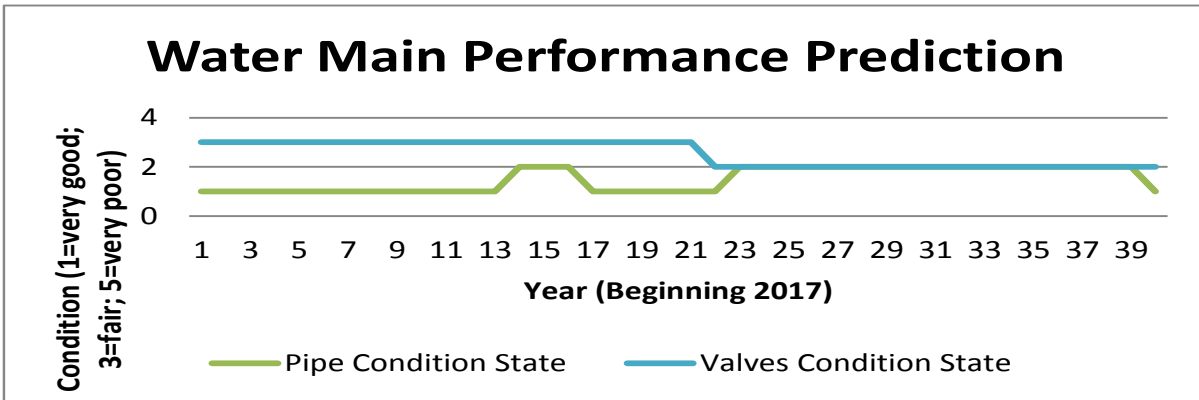
Figure 31– Water Mains Long-Range Performance Prediction Projection

The following figures work together in illustrating the expenditure needs versus performance of the water distribution infrastructure assets. The performance prediction models are indicating that the overall state of the water pipelines will remain in a very good “1” condition state for the next 14 years. At this time, there is expected to be approximately \$9 Million in pipeline renewal activity required. The associated valves are currently in a fair “3” condition state with on-going repair/replacement needed over the next 22 year. In year-22, it is expected the system will sustain a good “2” condition state until year 38, when the next surge of pipeline renewal is expected again.

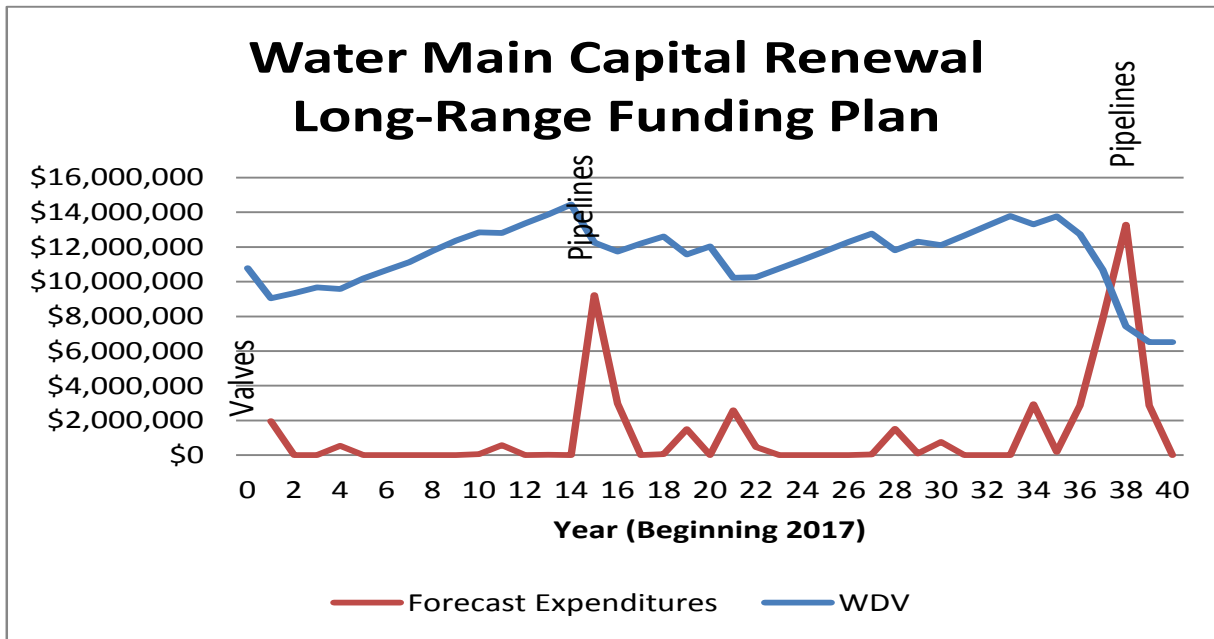
Figure 32– Water Mains Long-Range Funding Projection

As the deterioration cycles appear to be different, between the pipes and its associated valves, the short-term (i.e. 5-year) expenditure needs do not include any pipe replacement. The short-term allocation needs are entirely associated with the probability of valve failure and associated emergency repairs.

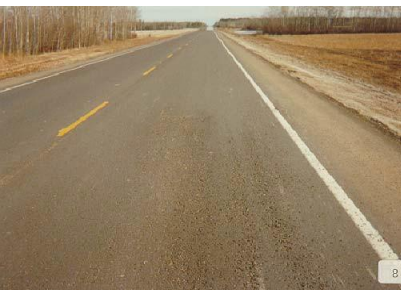
Moderate Surface Condition

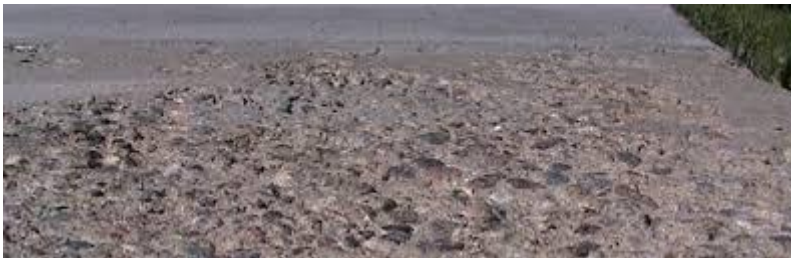
Moderate Sidewalk Spalling

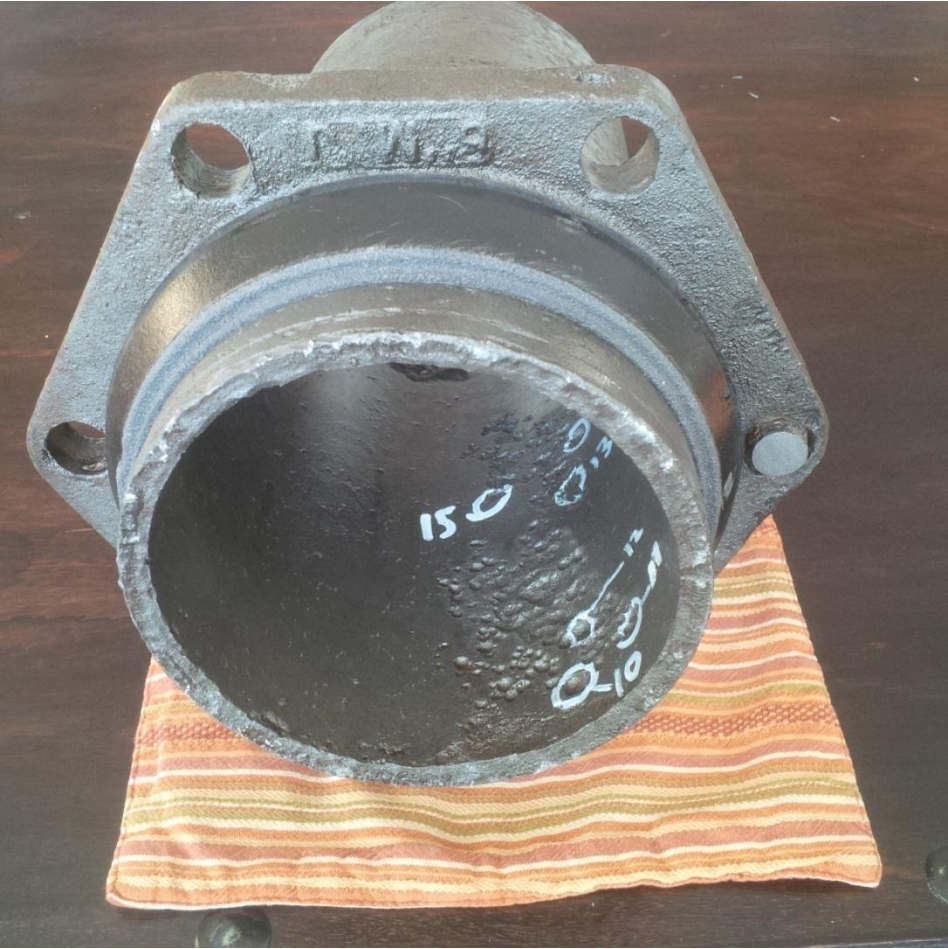
Minor Pitting (50-80 percent remaining wall thickness)

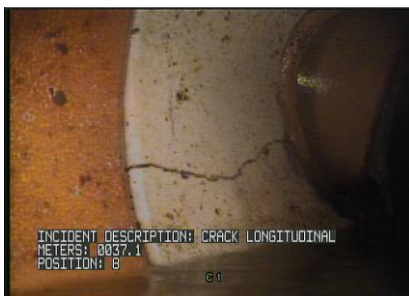
Moderate (Grade 3) Structural Defects

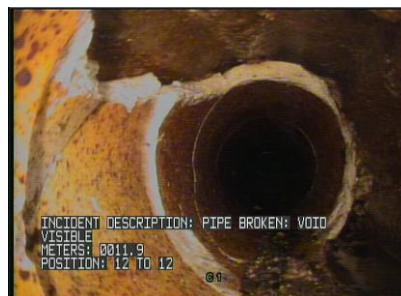
Severe (Grade 5) Structural Defects

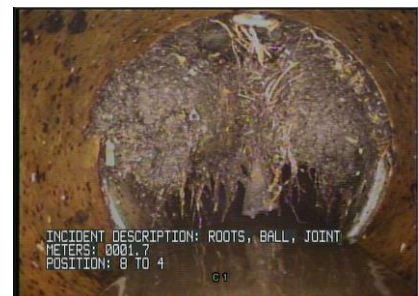
Severe (Grade 5) O&M Defects
