Jasper Activity Centre

Recreation Facility Assessment
April 2016

Architecture
Interior Design

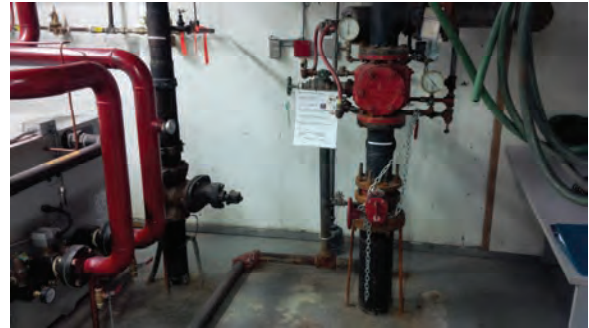
Activity center incoming water services

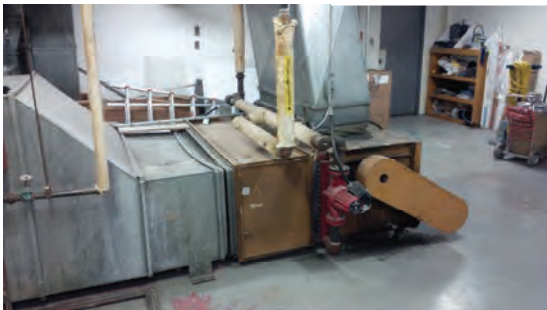
Activity center basement AHU

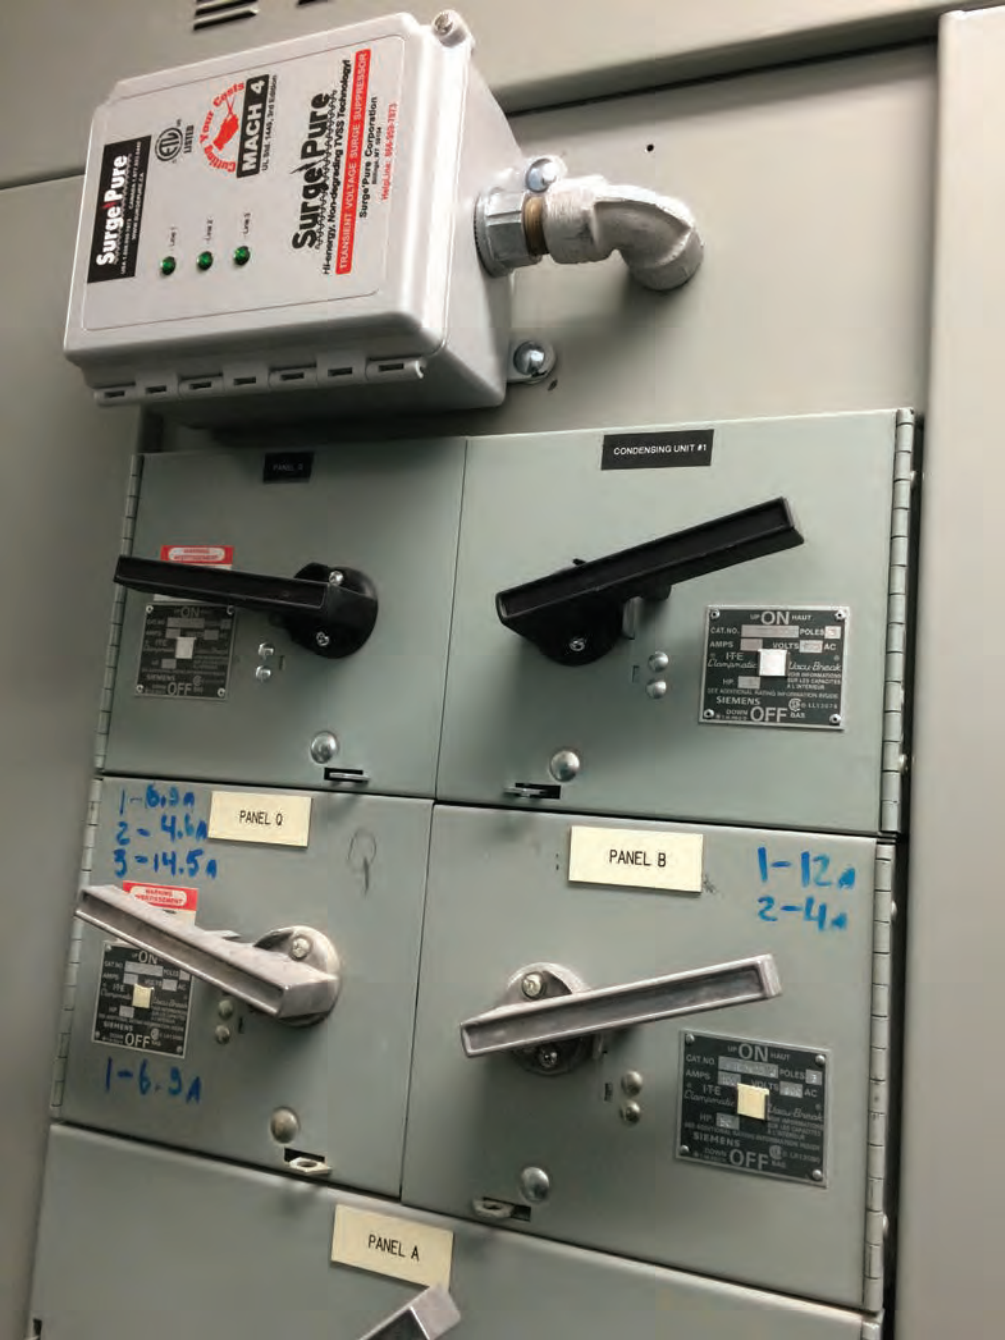
The main distribution board is a Siemens main distribution panel type assembly with fused disconnect switches. The main distribution board is fed from the electrical utility transformer noted in item 3.0 via underground secondary feeder. The main electrical service is 120/208volt, 800 ampere, 3 phase, 4 wire, complete with surge protection. The main distribution board is currently near full capacity based on available space. The system appears to have been installed during the renovation in 2010 and seems to be in adequate working condition.

Recommendation: The board appears to be servicing the needs of the site however there is not space for any future expansion. When/if expansion occurs, a new board should be considered.

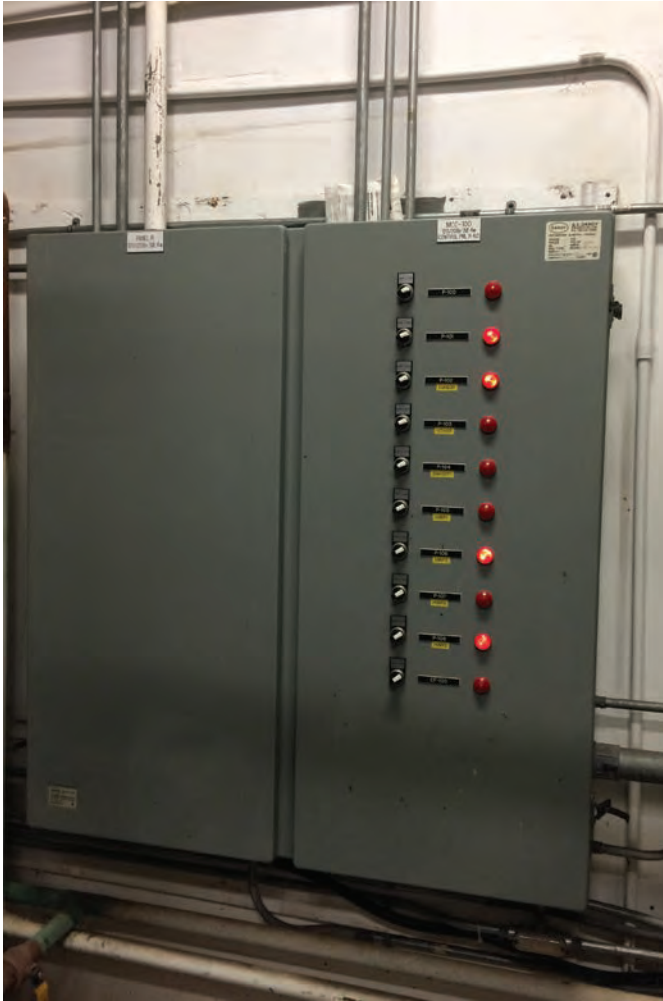
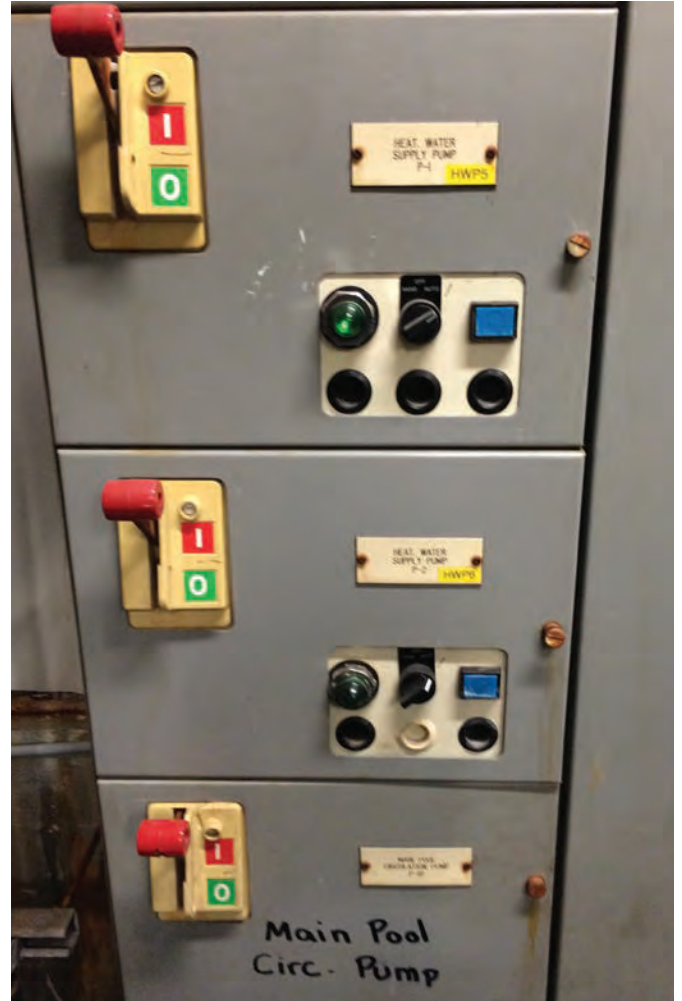
The wiring methods and condition of the existing wiring with the renovated areas of the facility is good. The state of the wiring in the pool area and the associated service areas is, in some cases, contrary to the Canadian Electrical Code and is severely corroded in some areas.

Recommendation: A thorough review of the wiring within the pool area and support spaces and replacement of some wiring within these spaces is recommended.

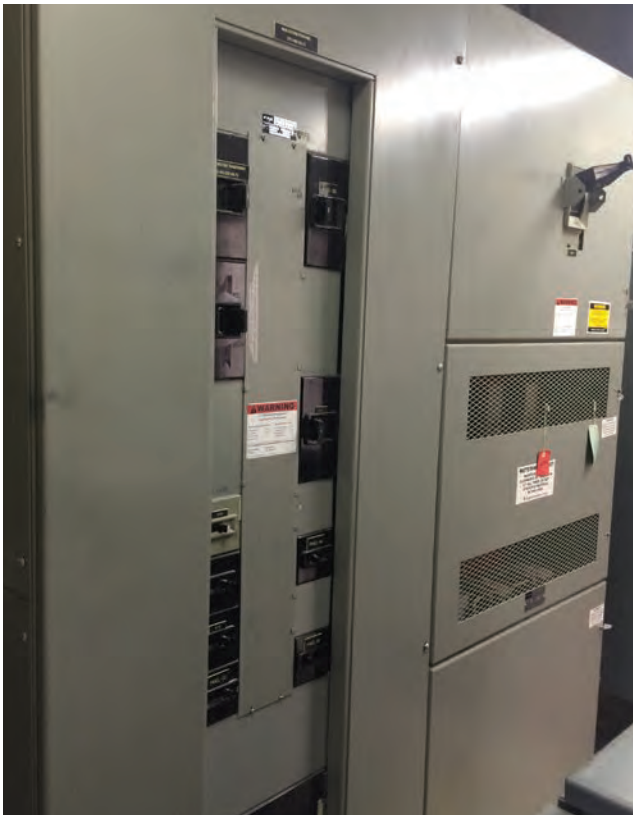
The main distribution board is a Federal Pioneer main distribution panel type assembly with moulded case circuit breakers and a main fused disconnect switch. The main distribution board is fed from the electrical utility transformer via underground secondary feeder. The main electrical service is 277/480volt, 1200 ampere, 3 phase, 4 wire. The main distribution board currently has adequate available space for additional breakers. The facility operators mentioned that they cannot run all three of their compressors in the ice plant out of fear they will trip the main breaker. They system was installed new at building opening in 1976 and has breakers that are not available for parts or servicing any longer. In front of the main board is a distribution transformer which infringes on the CEC required distance of 1m clear working space.

Recommendation: The board appears to be servicing the needs of the site however it is passed the expected life of the equipment and should be considered for replacement.

The transformer proximity to the main board is causing a code violation which should be rectified. Recommend reviewing the overall demand of the building through utility bills to determine future spare capacity of the system.

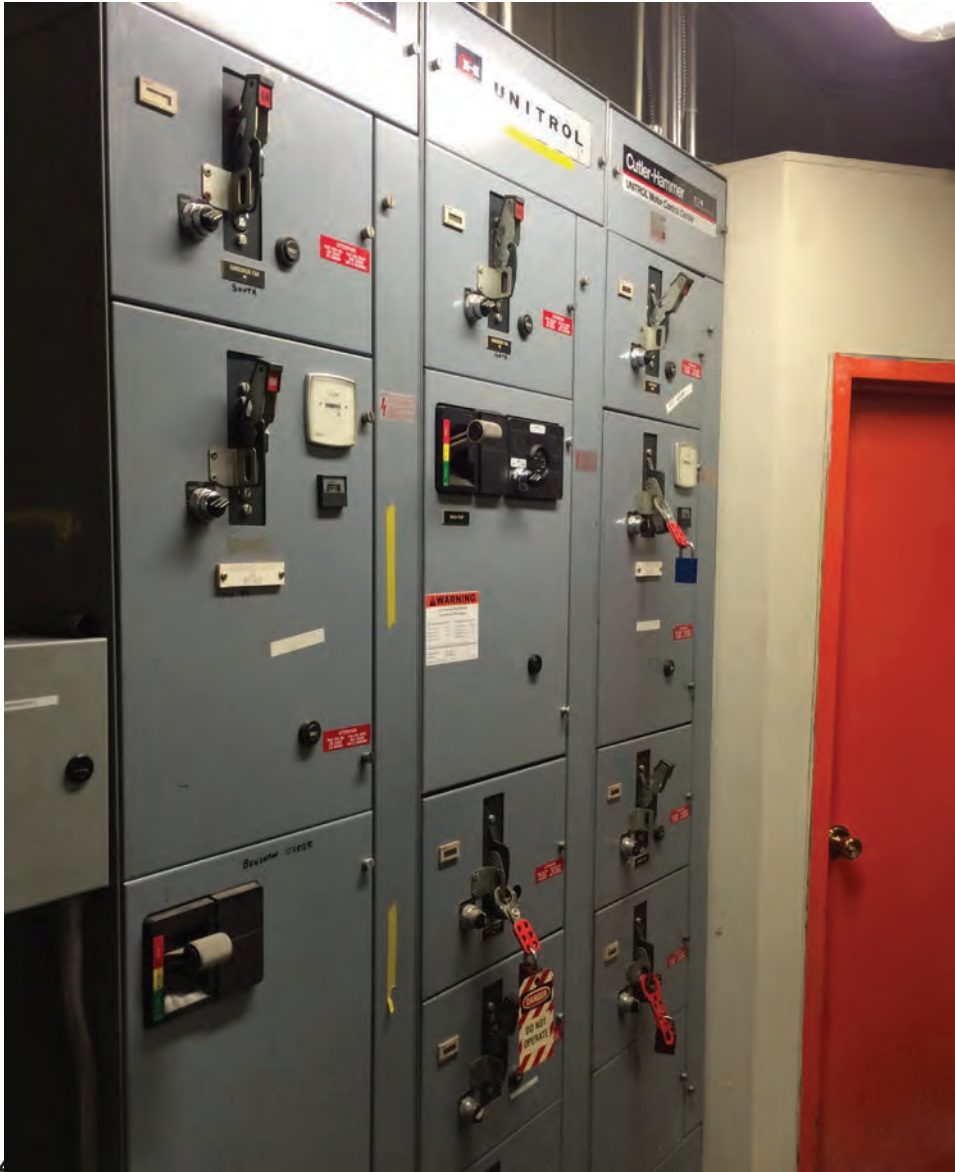
The wiring methods and condition of the existing wiring within the facility is a mix of conduit, BX and open air wiring. The state of the wiring in some cases is contrary to the Canadian Electrical Code.

Recommendation: A thorough review of the wiring within the facility and replacement of some wiring within is recommended.
